Goff Mill Brook Dam Removal

Report to the Maine Outdoor Heritage Fund

April 20th, 2016

Wells National Estuarine Research Reserve

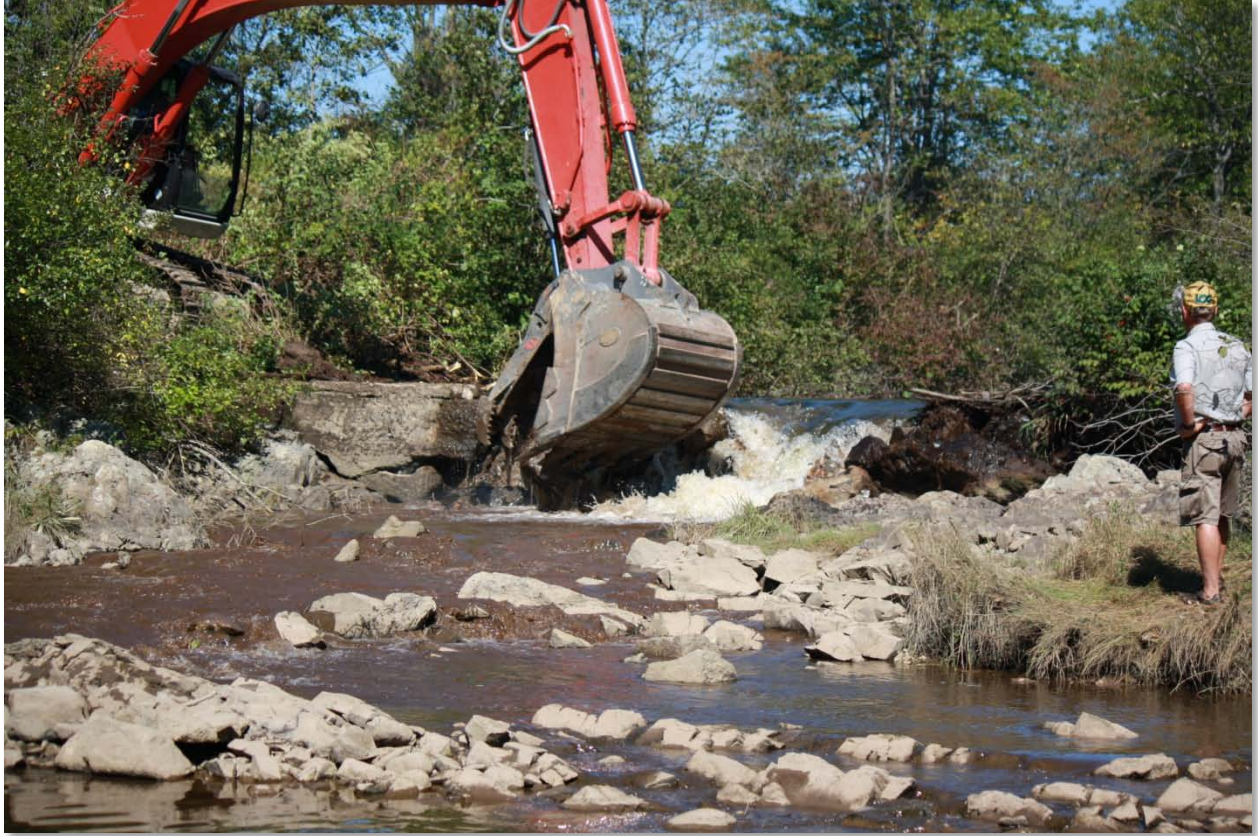
On the cover: Caribou Springs LLC removes the concrete and stone dam on Goff Mill Brook, September 18, 2015.

On September 18th, 2015 the dam at the head-of-tide on Goff Mill Brook was removed and natural flow restored to the stream. The removal was carried out by Caribou Springs LLC of Gilead, Maine and took approximately 60 minutes to complete. The impoundment drained completely in a few hours restoring natural flow and exposing riffle and pool habitat upstream of the dam site. This project restores connectivity between seven miles of freshwater habitat and the Gulf of Maine and enables upstream and downstream passage by aquatic organisms. In April 2016 rainbow smelt, brook trout, and sea lamprey were found passing upstream of the former dam site.

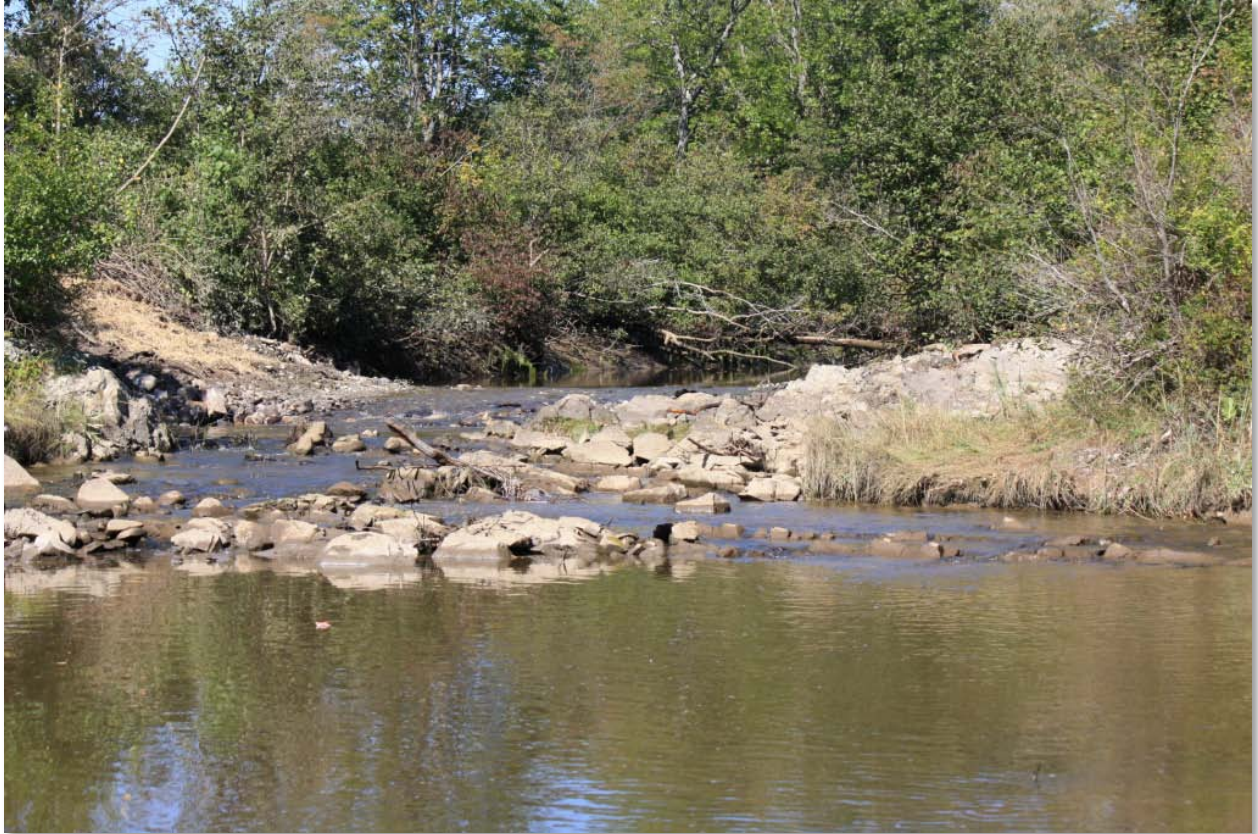
Goff Mill Brook now flows unimpeded to the Kennebunk River estuary and the Gulf of Maine.

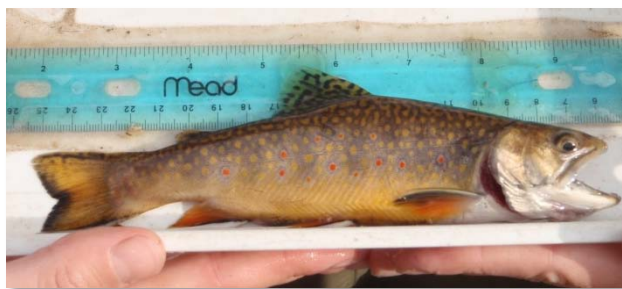
Wild brook trout were sampled in Goff Mill Brook in

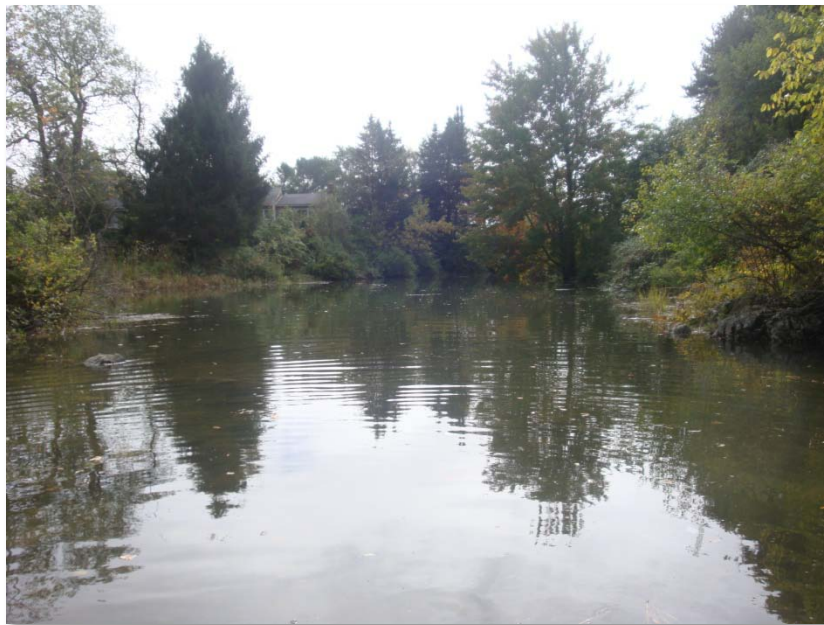
Tide water inundates the site of the former dam on Goff Mill Brook in September 2015.

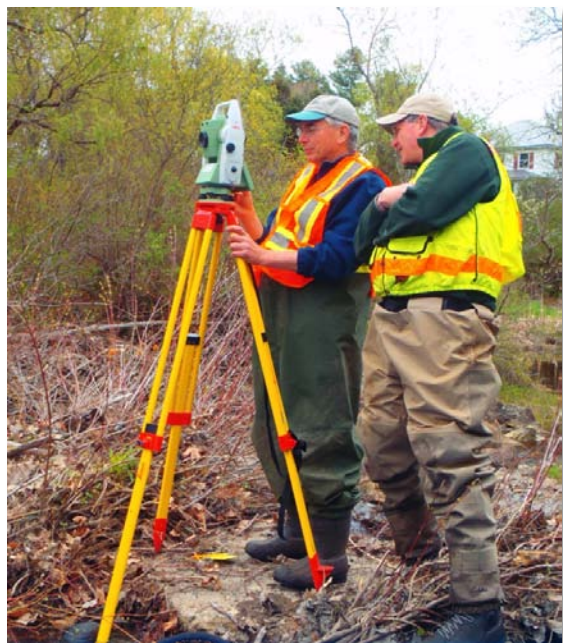
Elevation measurements were collected with a Total Station to help quantify the changes expected from dam removal.

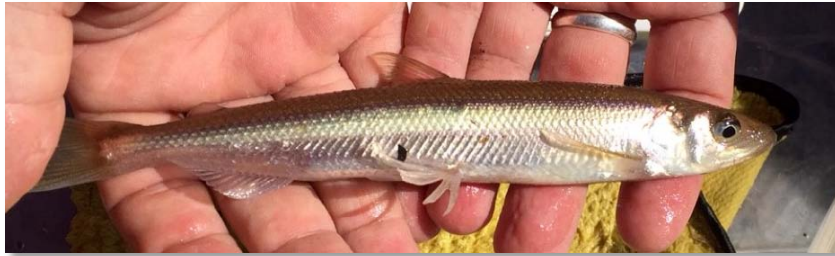
Rainbow smelt sampled in April 2016 successfully passing upstream of the former dam site.

As of April 2016, natural substrate continues to emerge as accumulated silt flushes out of the restored stream. The emergence of hard cobble and gravel substrate has provided habitat for aquatic invertebrates to colonize, improving food sources for insect-eating fish and wildlife. Initial surveys of fish utilizing the restored reach have yielded immediate positive results. On April 13th several fish were caught moving upstream of the former dam site including a brook trout and a rainbow smelt. The following day, on April 14th, two sea lamprey and two white suckers were captured, along with three-spine sticklebacks and mummichogs. These species would not have been able to pass the dam. Presence of rainbow smelt is an important find as this species is a federally listed species of concern. The presence of mummichogs and 3-spine
