KENNEBUNK RIVER

WATER QUALITY REPORT & WATERSHED STRESSOR GUIDE

FB Environmental Associates

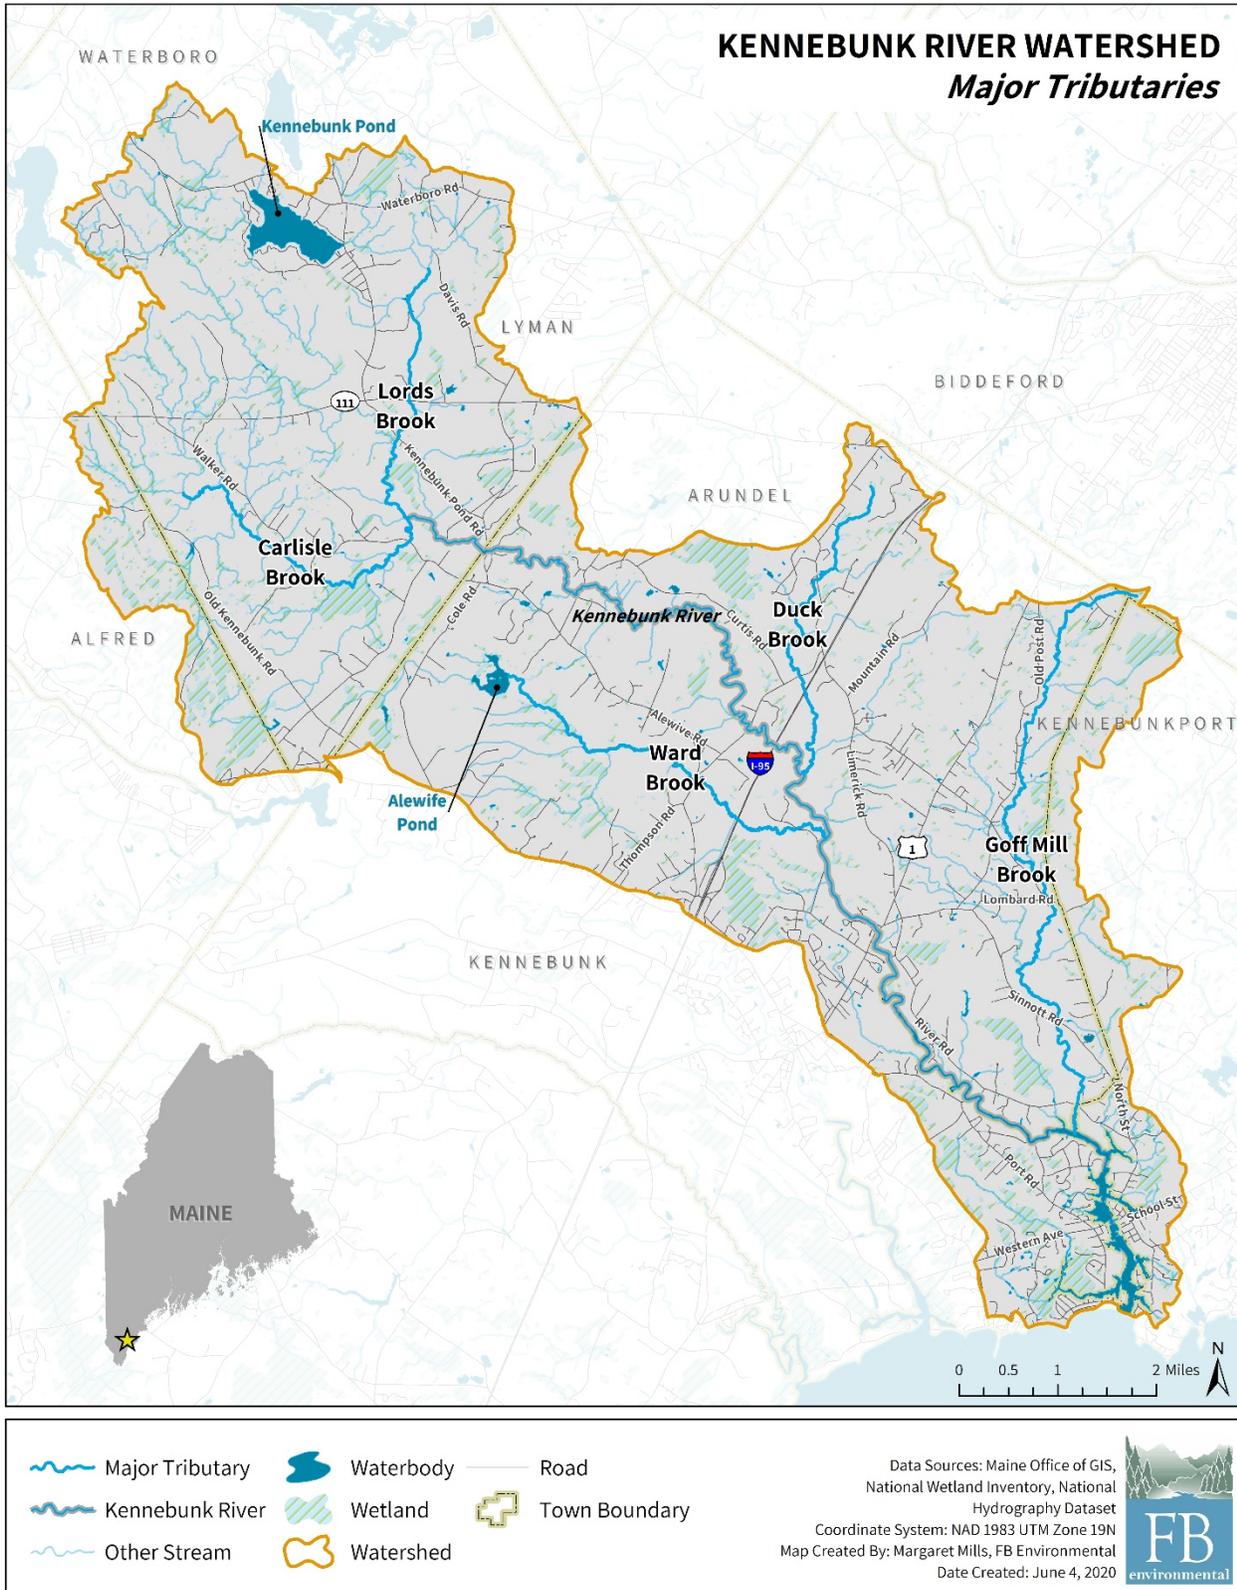
Figure 1. Major tributaries in the Kennebunk River watershed used for analysis in this guidance document.

It is important to note that the 2019 Stressor Guide does not address bacteria impairments, such as the ones in the Kennebunk River and Duck Brook. However, we will have applied the outlined approach to our restoration plan for the bacteria impairments in the Kennebunk River watershed. At 59 sq. mi. and across six towns, the Kennebunk River watershed is large. Because of its size, we completed this stressor-based approach for each major tributary sub-watershed individually as well as the direct drainage of the Kennebunk River (see map on Figure 1, on the following page). The focus tributaries for this analysis were:

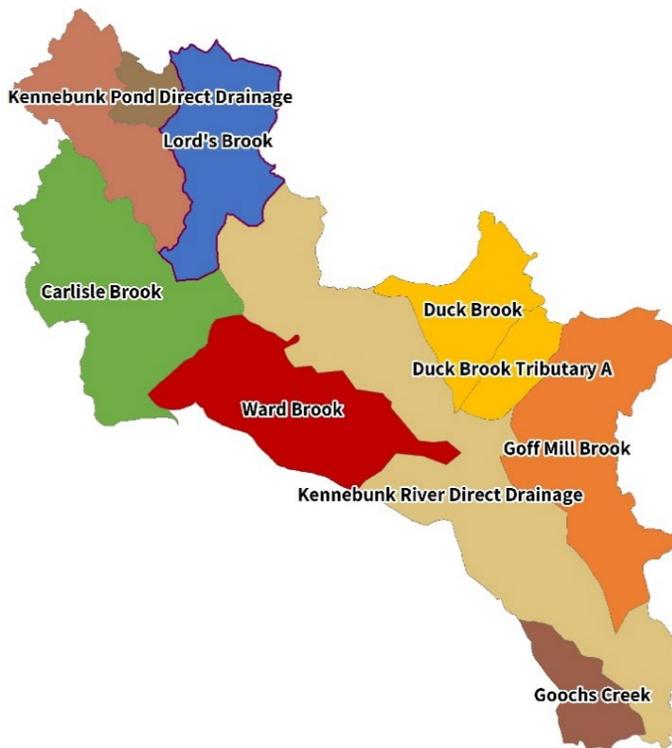
Figure 3a. Sub-watersheds located in the Kennebunk River watershed, with assigned colors that will be used throughout the document to indicate a specific sub-watershed.

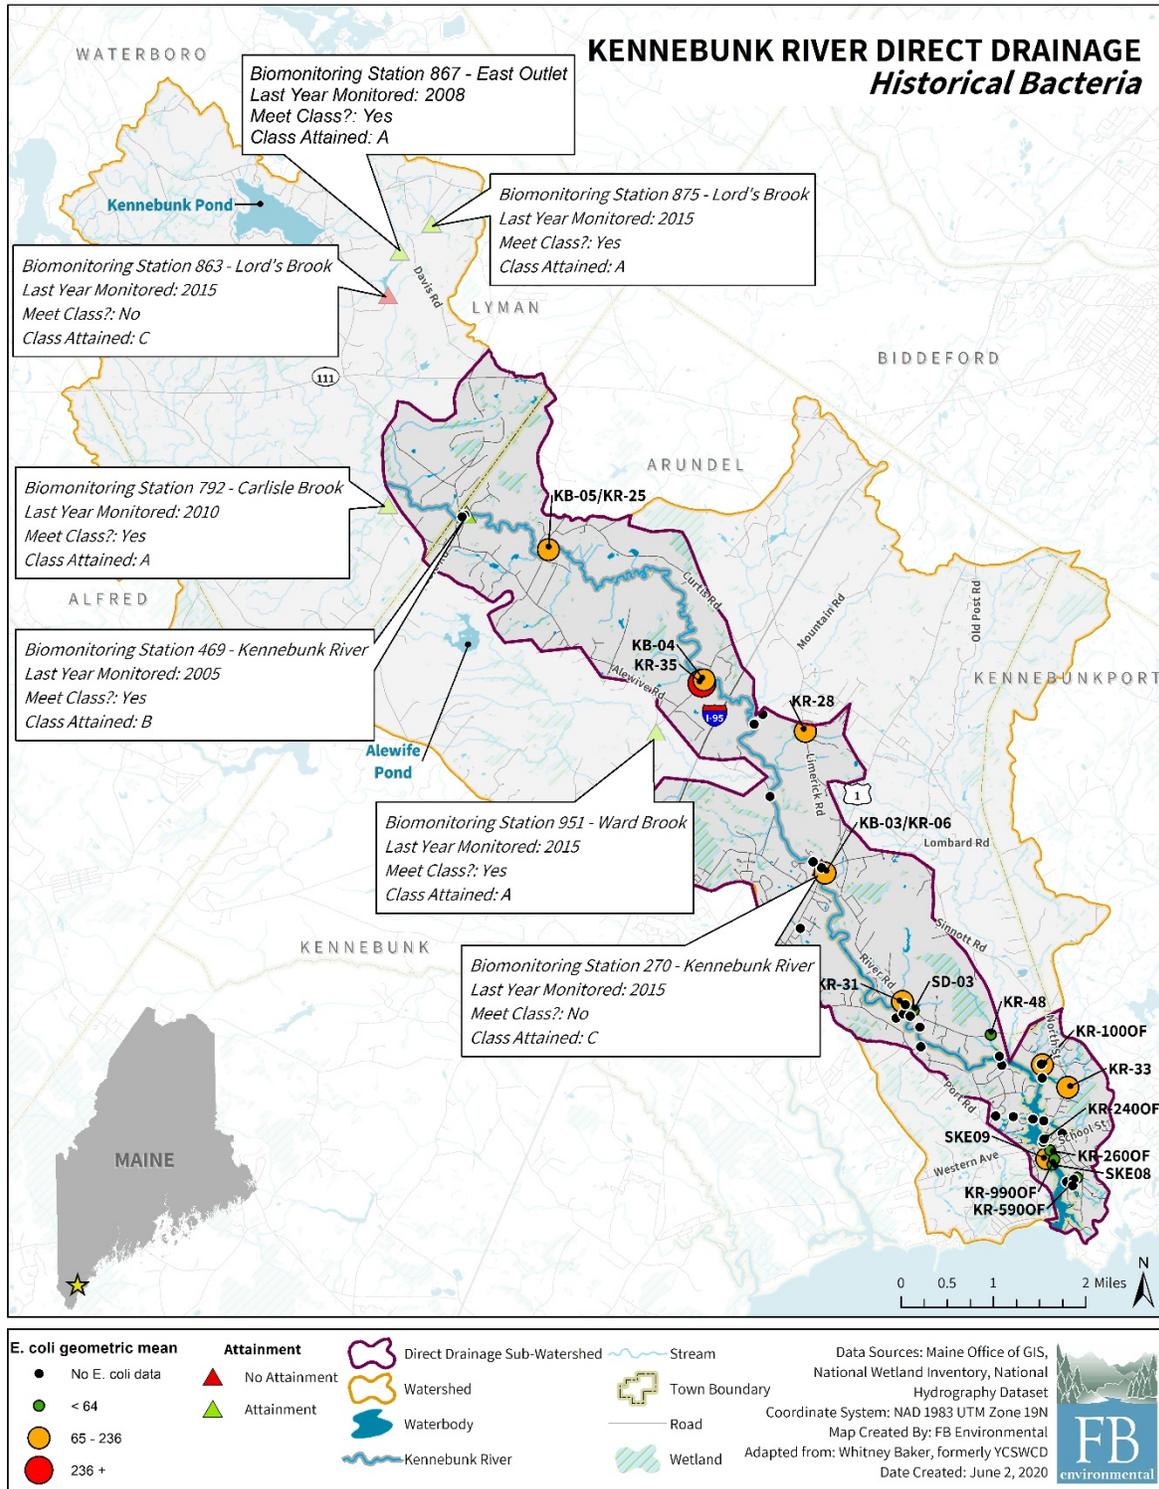
Figure 4. Geometric mean (MPN/100mL) for all sites with historical *E. coli* data within the direct drainage of the Kennebunk River. Represented data includes all years with data truncated to the summer season. Scaled/colored dots indicate the magnitude of the historical geomean and represent the Maine DEP geomean criteria (64 MPN/100mL) and tenth percentile (236 MPN/100mL). Sites with no *E. coli* data are represented as black circles.

E. coli data is available for 16 sites in the Kennebunk River direct drainage. Of these 16 sites, four had six or more datapoints with the majority of sites again having only one reading. These four sites are outlined in Table 4. Mean *E. coli* (geometric mean) is elevated at all three sites at 175.2, 213.5, 141.8, and 110.1 MPN/100mL for KB-03, KB-04, KB-05, and SKE09, respectively. However, all sites have a high standard deviation (>500) reflecting the extreme variability noted in *E. coli* samples. Maximum *E. coli* was greater than the detection limit (2,420 MPN/100mL) for three sites (KB-03, KB-04, and KB-05). All *E. coli* data within the Kennebunk River direct drainage is presented visually in the Figure 4 map (p.14), including sites with only one datapoint.

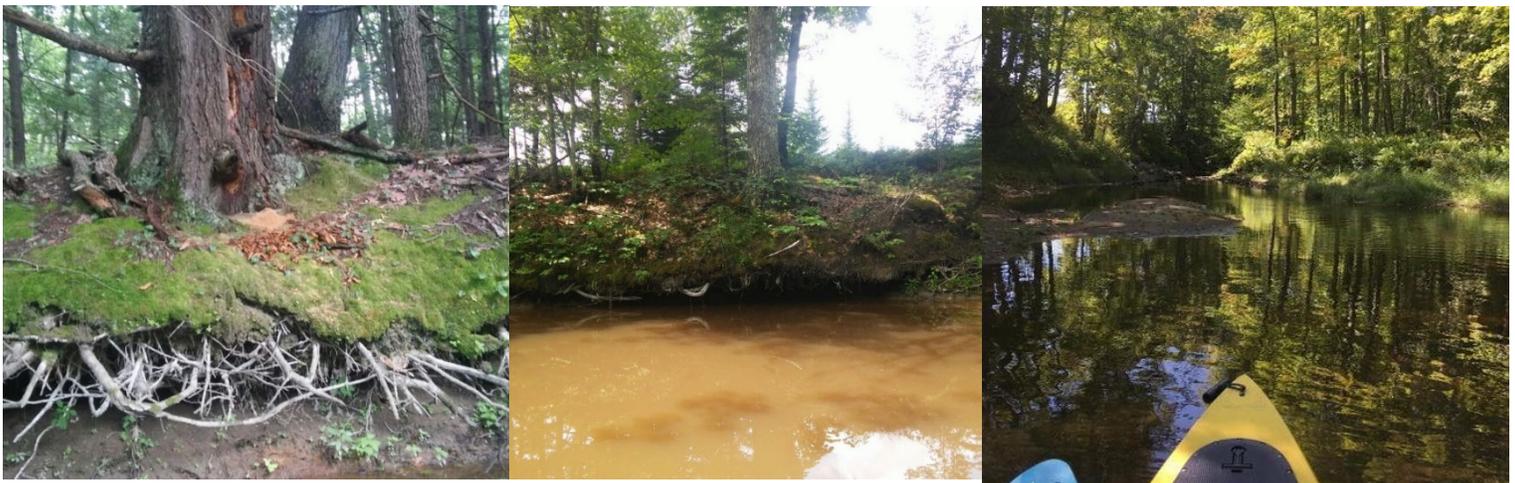
Photos taken in the Kennebunk River. (Left) exposed tree roots with undercut banks, (middle) high turbidity along the main stem, and (right) a forested section of the Kennebunk River.

A stream corridor assessment⁶ took place in the Kennebunk River main stem to provide a different perspective on nonpoint source pollution sites and in-stream conditions. This included a 1.9-mi segment above Route 1 and below biomonitoring station 270 as well as a 1.8-mi section downstream of Perkins Lane. Most notable in these surveys was the occurrence of exposed tree roots, large organic debris, and fallen or leaning trees and fence posts. Areas of significant bank erosion were visible along the channel. Several areas had soft sediment beds and high turbidity below the confluence with Ward Brook, which indicates mobile sediments. Water levels were generally low at the time of survey. Low water levels and high banks prevented observers from documenting the land use beyond the near riparian banks.

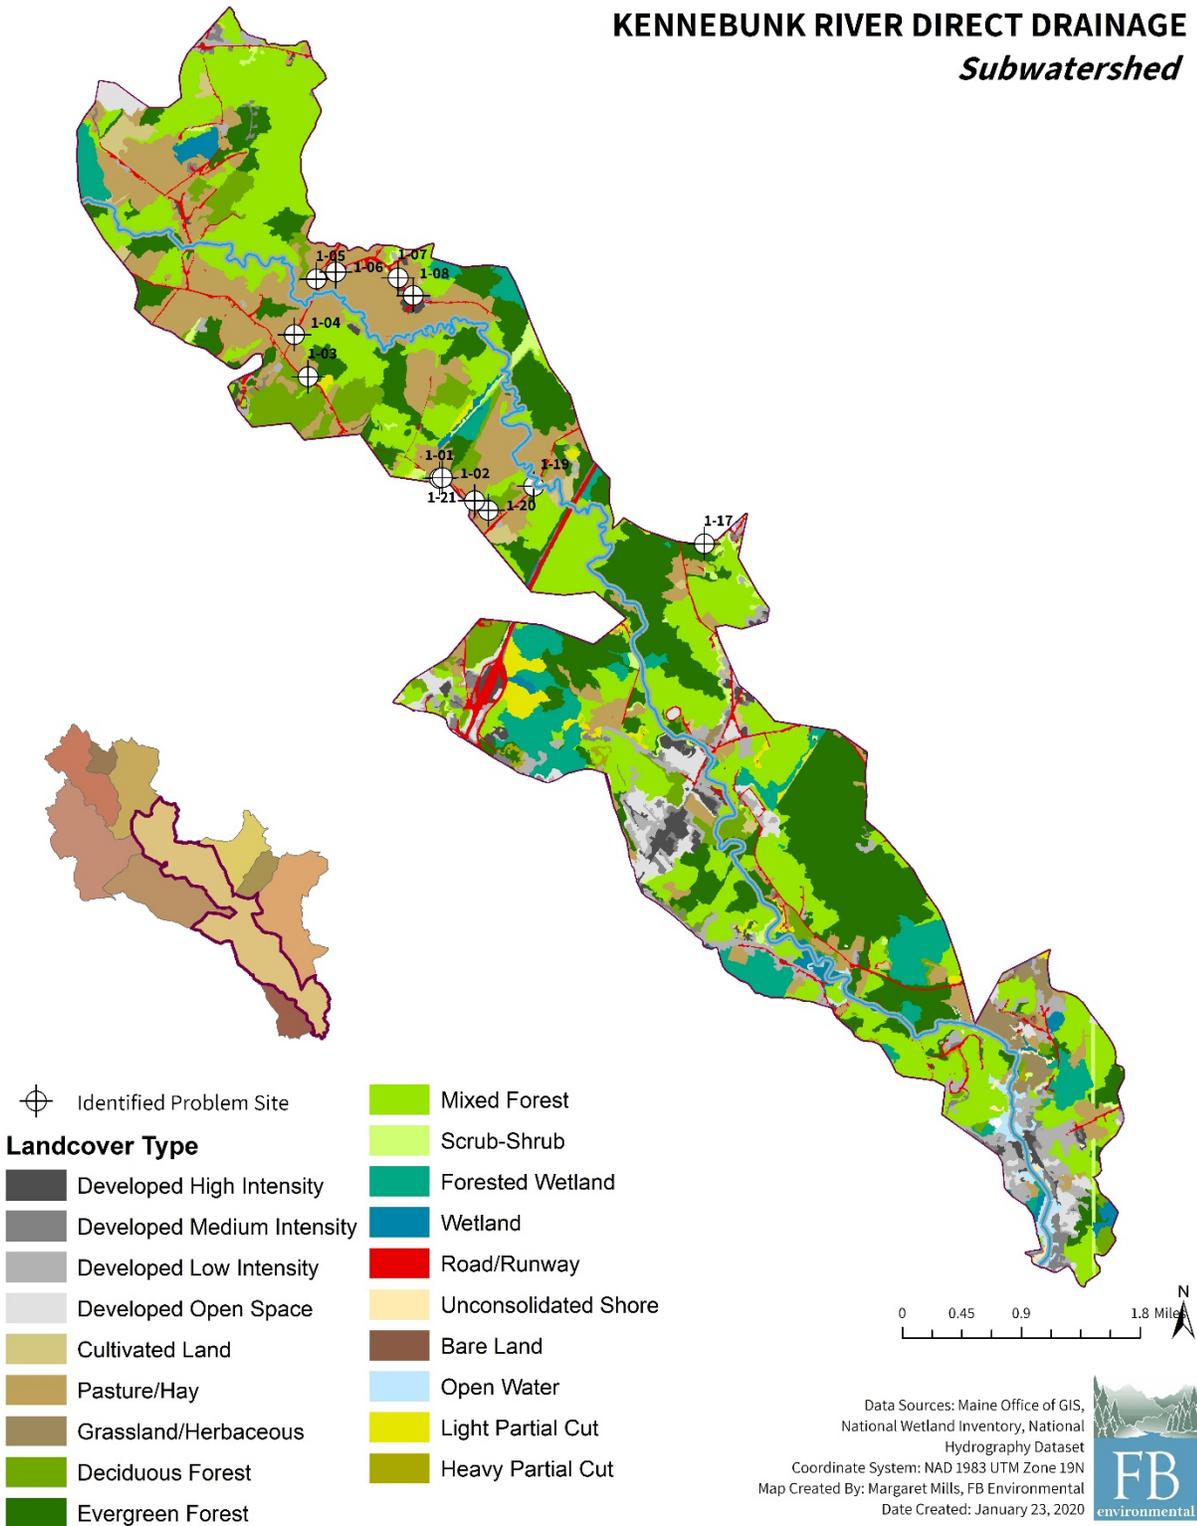
Figure 5. Land cover within the direct drainage of the Kennebunk River main stem.

The Kennebunk River direct drainage sub-watershed is 16.6 sq. mi. and represents the entire length of the main stem of the river from its headwaters in Lyman to its intersection with the ocean in Kennebunkport. Land use in the direct drainage area is diverse, with significant tracks of forest along its length (Figure 5). The estuarine portion of the sub-watershed is heavily developed with residential and commercial development. (Developed land includes impervious surfaces such as roads, driveways, sidewalks, and roofs.) Pockets of agriculture (cultivated land and grazing land) exist along the northern portion of the river downstream of Perkins Lane. Other significant landuse include the Cape Arundel Golf Course along the northern banks of the river.

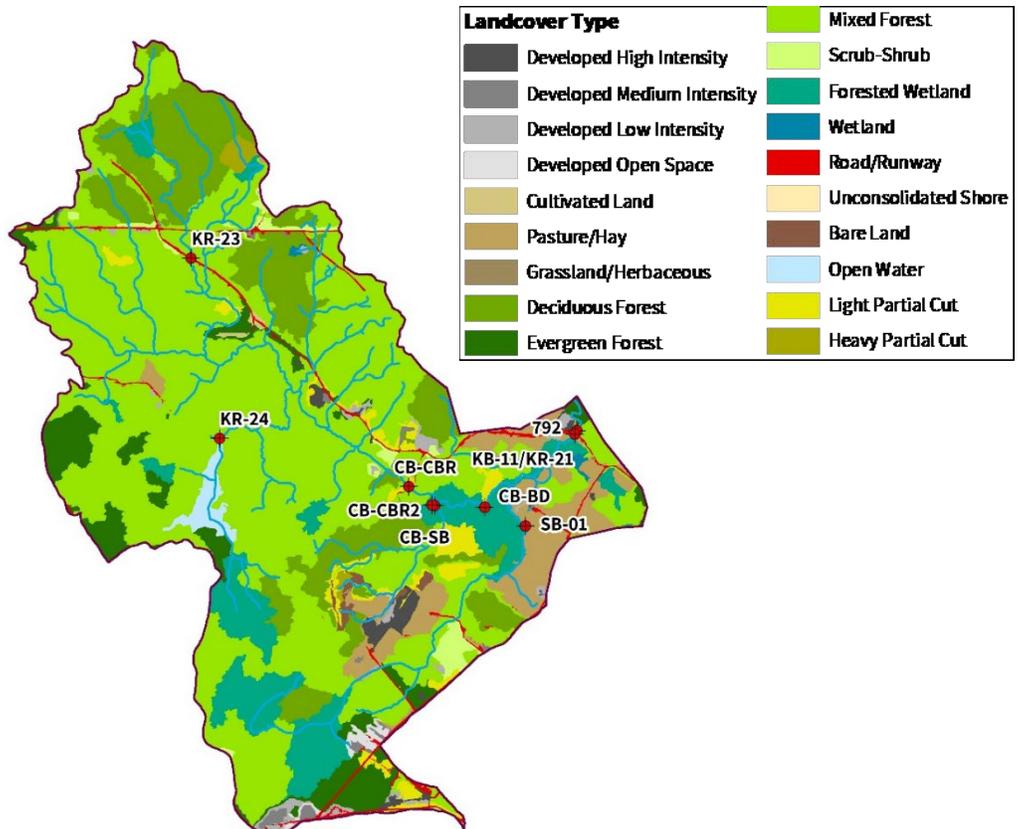
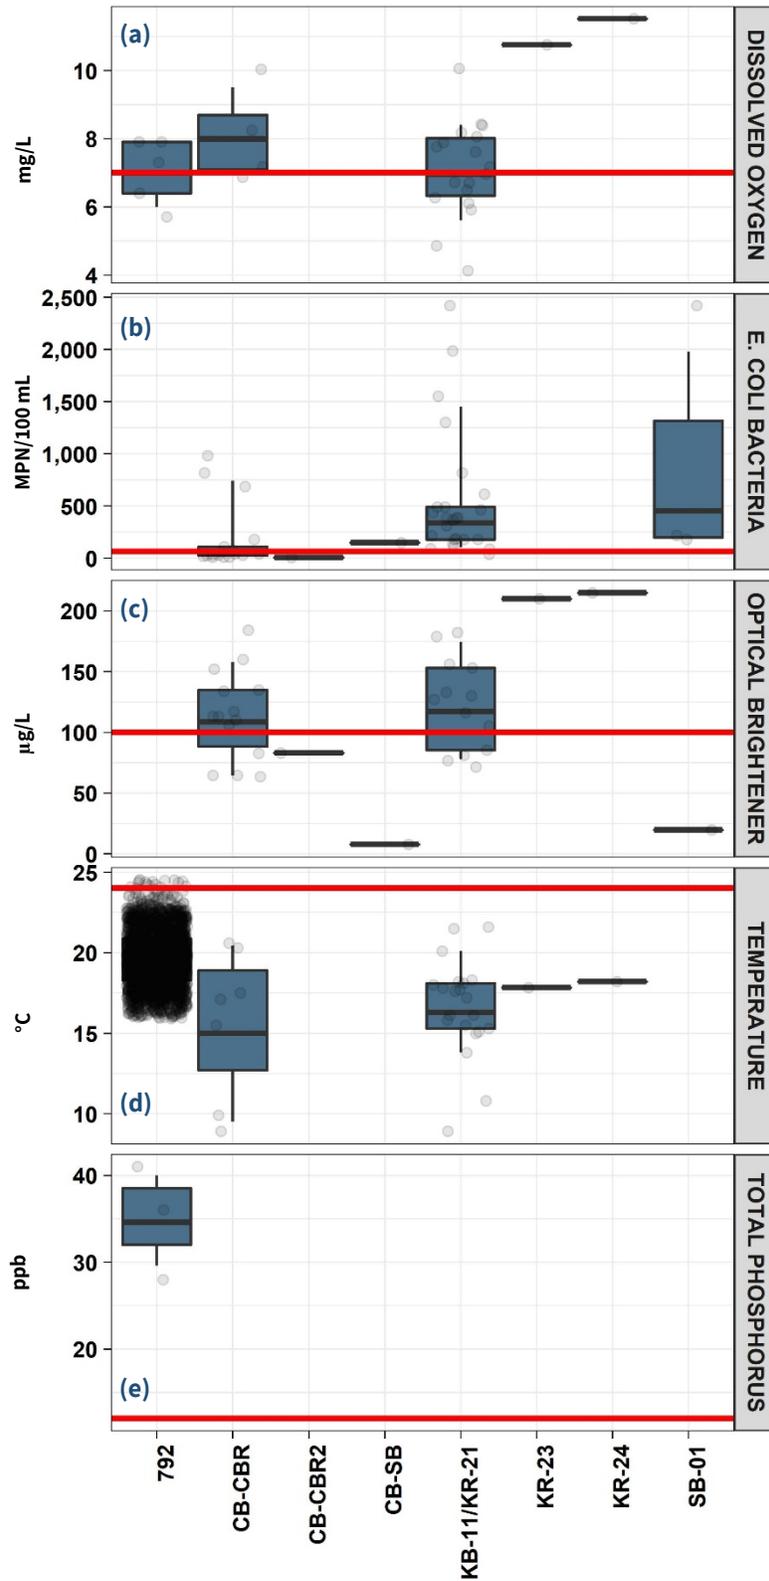
Figure 6. Boxplots showing the geometric mean, 25th, and 75th percentiles for (a) dissolved oxygen, (b) E. coli, (c) optical brighteners, (d) temperature, and (e) total phosphorus in the Carlisle Brook sub-watershed. Temperature at site 792 reflect a continuous monitoring device. *The red line indicates applicable state and federal thresholds for each parameter (refer to Table 1).*

Dissolved Oxygen: Dissolved oxygen data is available for sites 792 (average 7.0 mg/L, n=5), CB-CBR (average 8.1 mg/L, n=4), KB-11/KR-21 (average 6.9 mg/L, n = 17), KB-23 (average 10.8 mg/L, n=1) and KR-24(average 11.5 mg/L, n=1; Figure 6a).

Temperature: Temperature data is available for sites 792 (mean 19.6°C,n=2,522), CB-CBR (2018 only, mean 15.7°C, n=7), KB-11/KR-21 (2017 and 2018, mean 16.6°C, n=20), KB-23 (mean 17.8°C, n=1) and KR-24 (mean 18.2°C, n=1). Mean (geometric) temperature was below the recommended threshold of 24°C for aquatic organisms at all sites with a maximum recorded temperature of 24.5°C at site 792 (continuous logging data from 2010; Figure 6d).

Total phosphorus: Three samples at site 792 had a mean total phosphorus concentration of 35 ppb (Figure 6e).

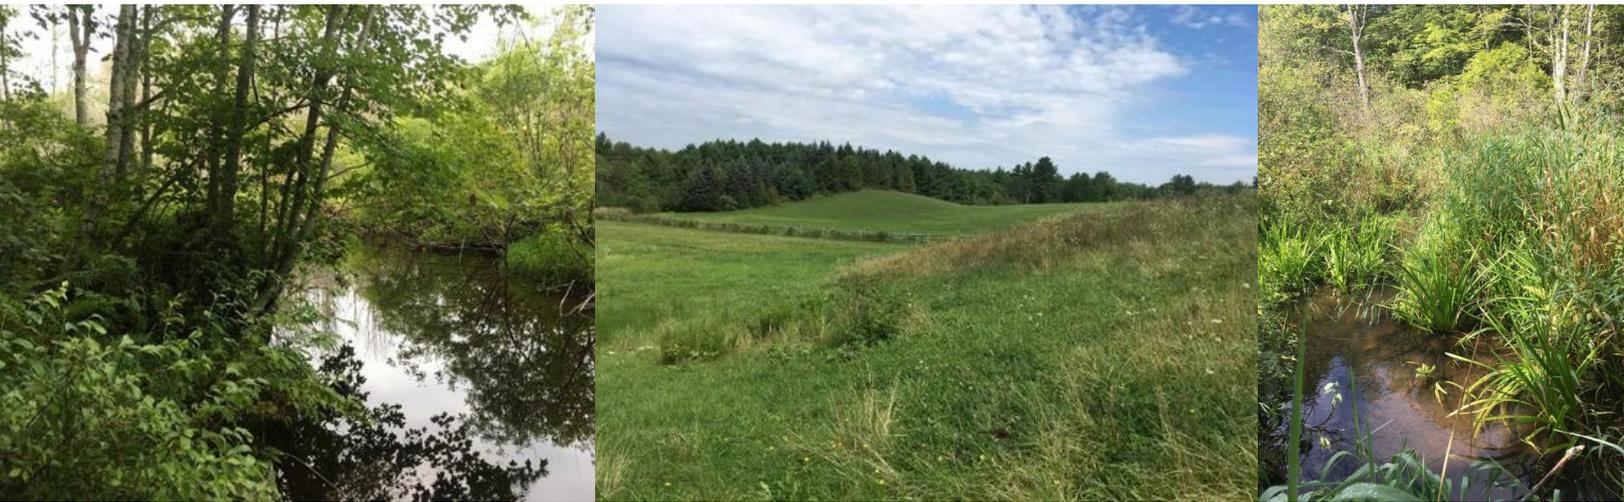
Photos taken in the Carlisle Brook watershed. (Left) ponding caused by a beaver upstream of Walker Road, (middle) fields at Carlisle Academy Integrative Therapy & Sports, and (right) ponding on a small tributary of Carlisle Brook. Numerous small tributaries feed into Carlisle Brook that have not been surveyed.

Environmental stressors: Elevated bacteria, ponding, and low water velocity.

Possible sources: Livestock farms, manure, beaver dams, logging, and excavation.

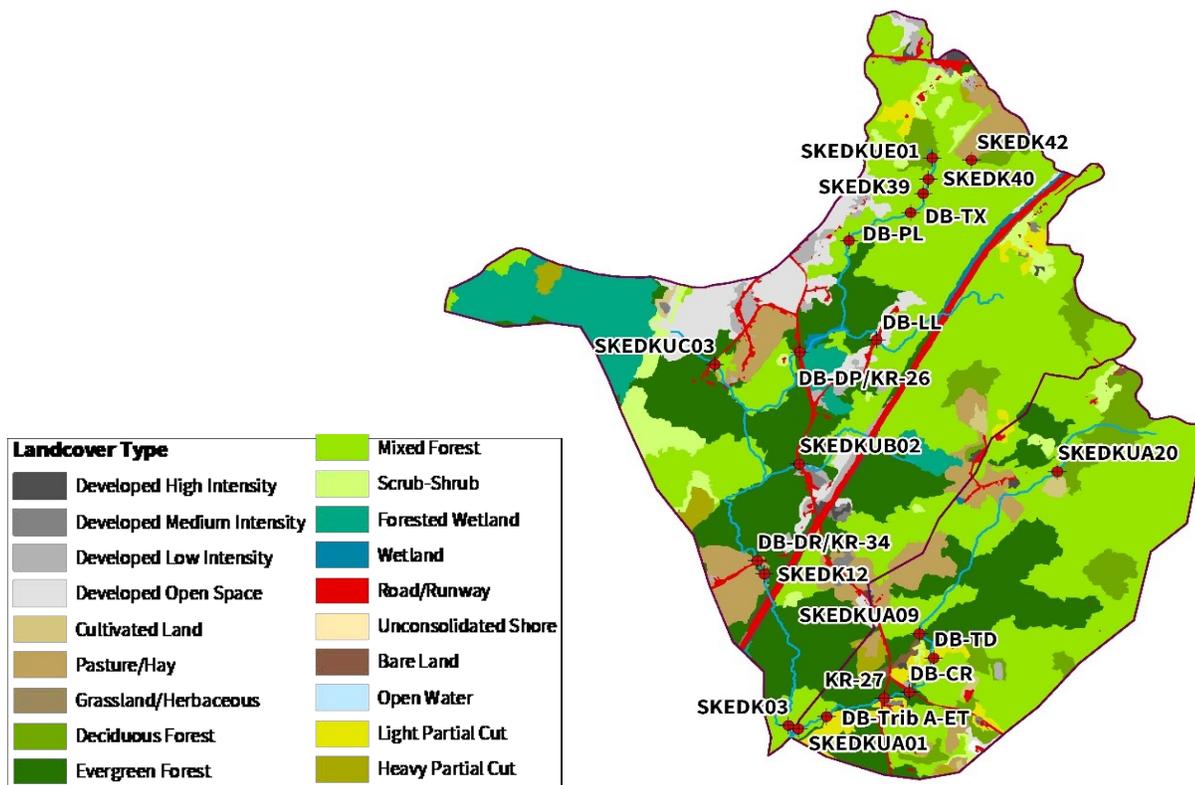
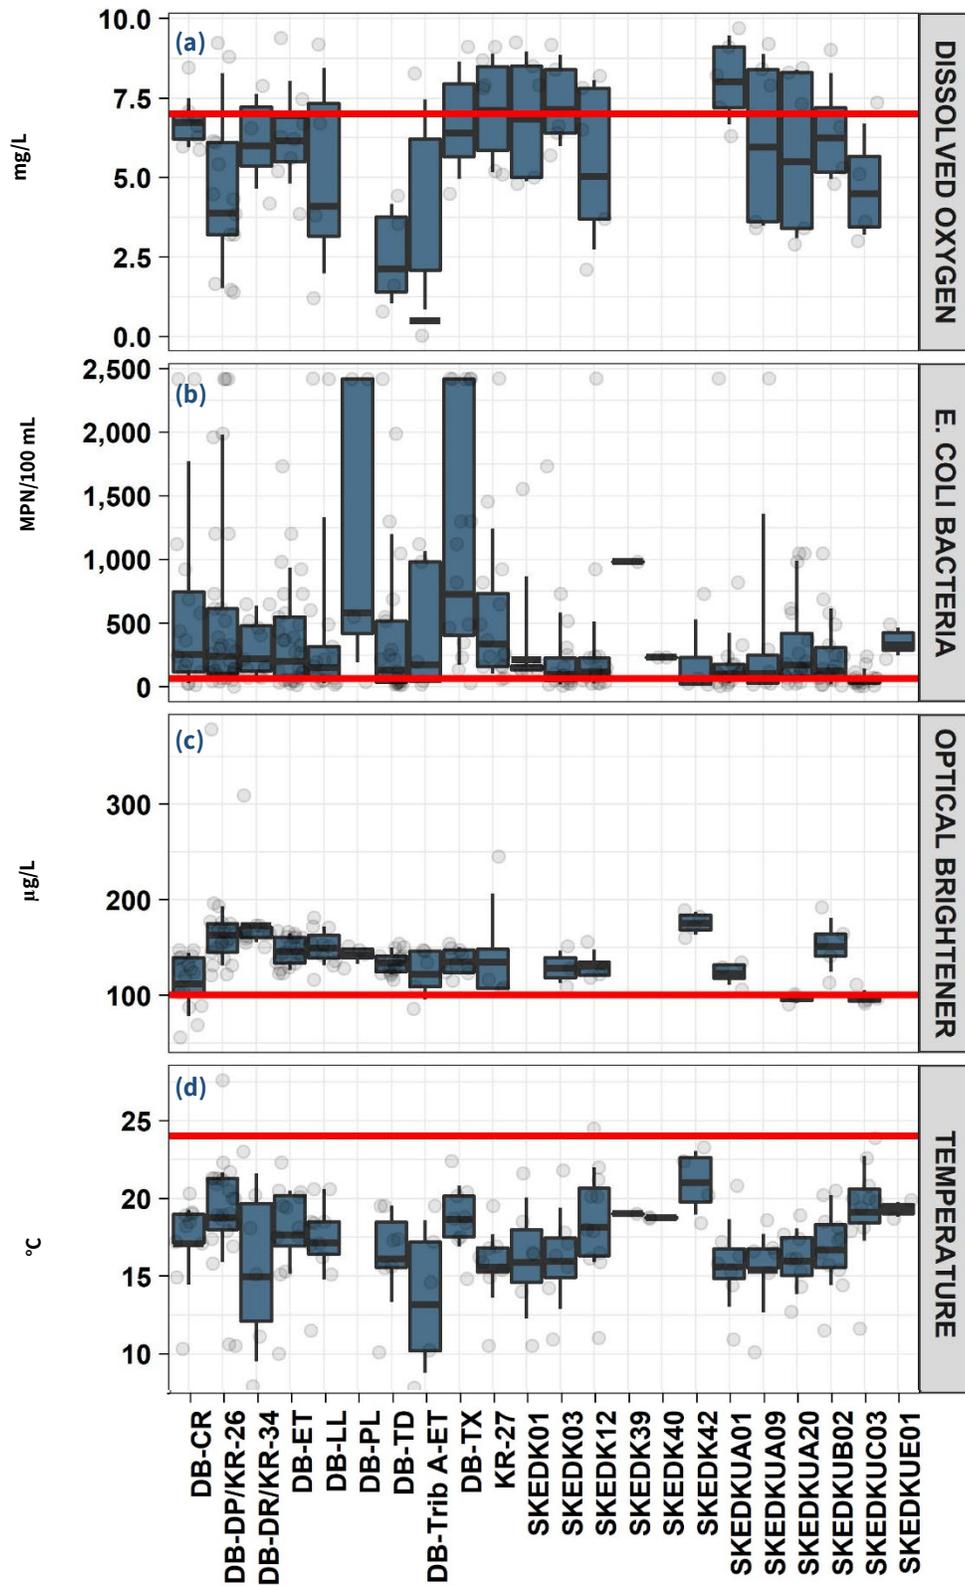
Figure 7. Boxplots showing the geometric mean, 25th, and 75th percentiles for (a) dissolved oxygen, (b) *E. coli*, (c) optical brighteners, and (d) temperature. The red line indicates applicable state and federal thresholds for each parameter (refer to Table 1)

Temperature: Temperature data is available for 21 sites in the Duck Brook sub-watershed. Mean (geometric) temperature was below the recommended threshold of 24°C for aquatic organisms at all sites, however maximum recorded temperature at two sites was above the threshold (site DB-DP/KR-26 at 27.6°C and site SKEDK12 at 24.5°C, n= 22 and 11, respectively; Figure 7d).

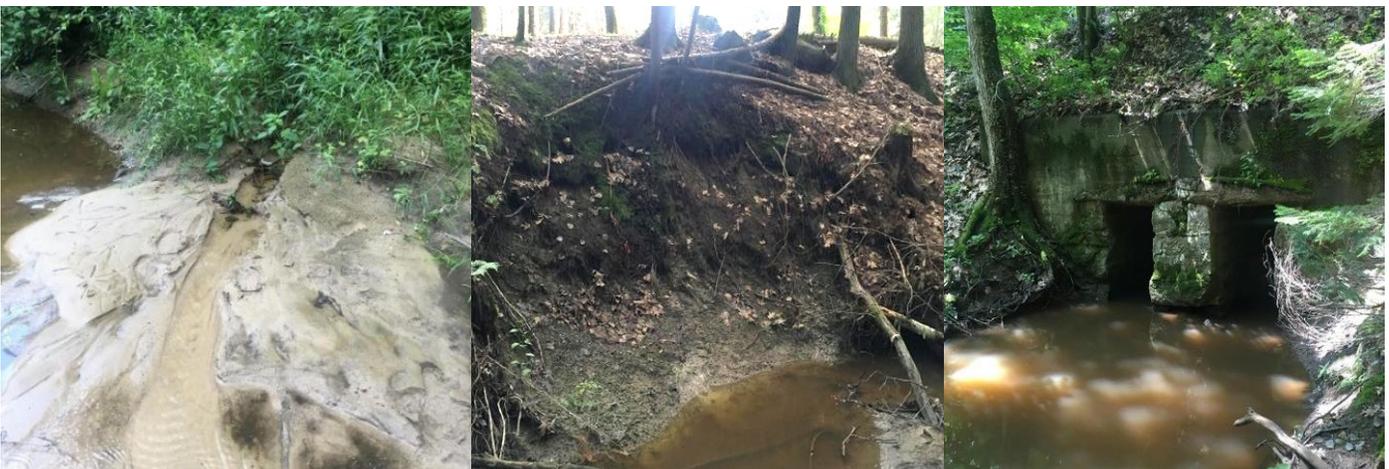
Photos taken in the Duck Brook watershed. (Left) a drainage entering the tributary above, (middle) bank erosion, (right) outlet of the Duck Brook Tributary A at the eastern trail. Small tributaries feeding into Duck Brook Tributary A were not surveyed.

In 2019, a stream corridor assessment was performed on a 0.8-mile segment of Duck Brook Tributary A (from the confluence with Duck Brook up to the Talbot Road crossing). An unusual conditions assessment⁷ was performed on this segment with the following key observations:

- Livestock and improper manure storage (not located directly in a waterbody).
- Unstable construction sites.

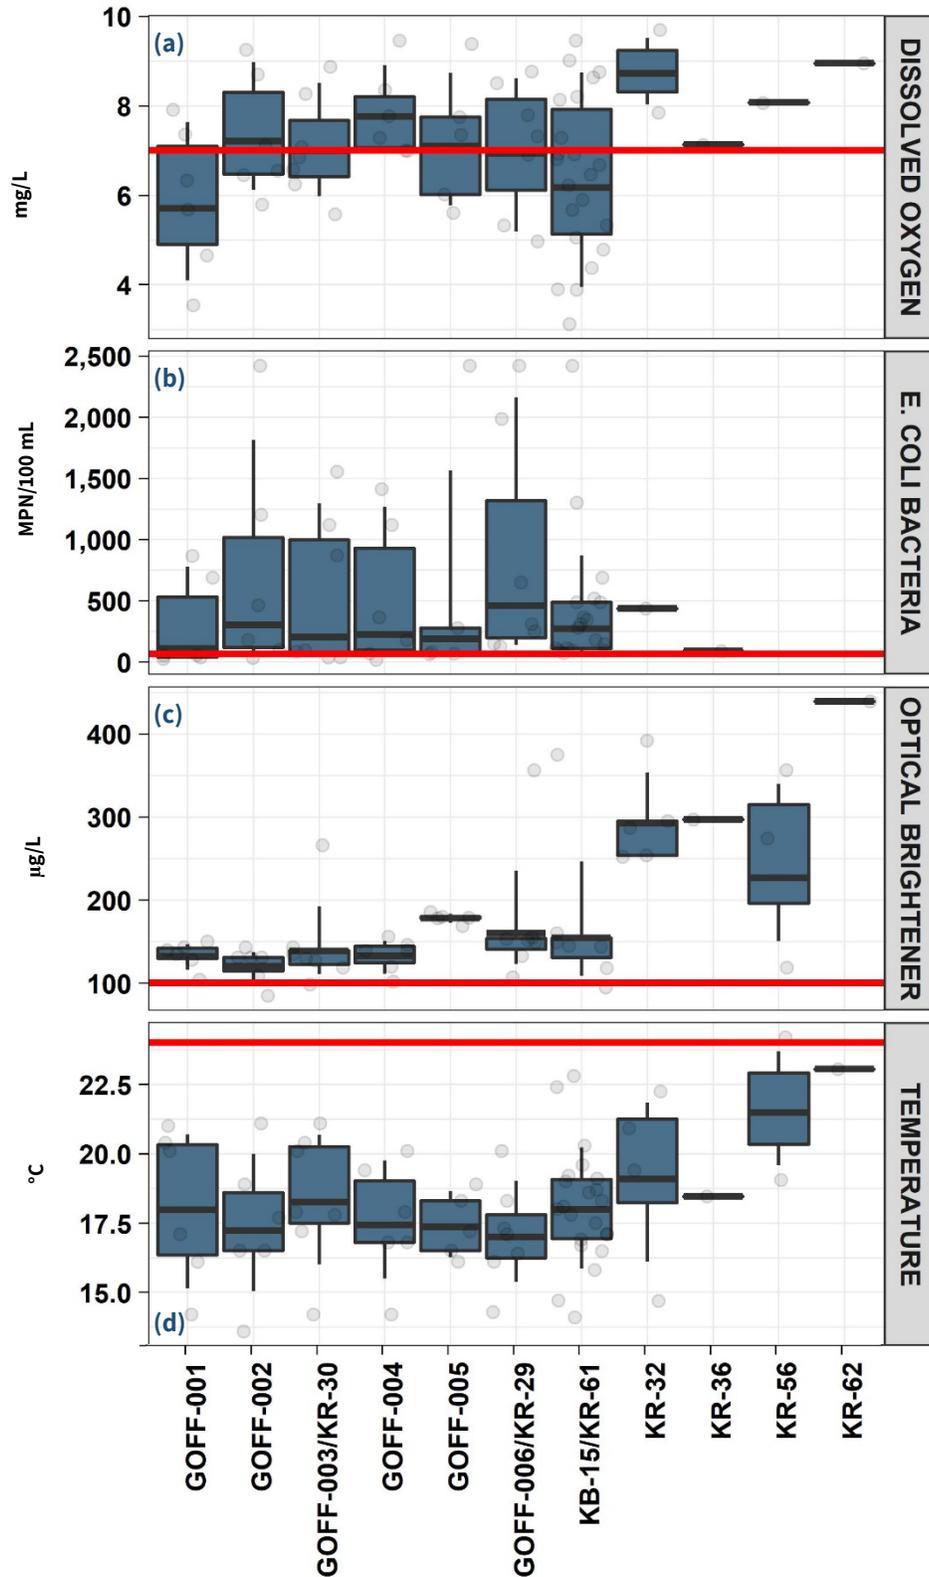
Figure 8. Boxplots showing the geometric mean, 25th, and 75th percentiles for (a) dissolved oxygen, (b) *E. coli*, (c) optical brighteners, and (d) temperature in the Goff Mill Brook sub-watershed. The red line indicates applicable state and federal thresholds for each parameter (refer to Table 1)

Temperature: Temperature data is available for 67 samples across 11 sites. Geometric mean temperature was below the recommended threshold of 24°C for aquatic organisms at all sites. Maximum recorded temperature at site KR-56 is 24.2°C; Figure 8d).

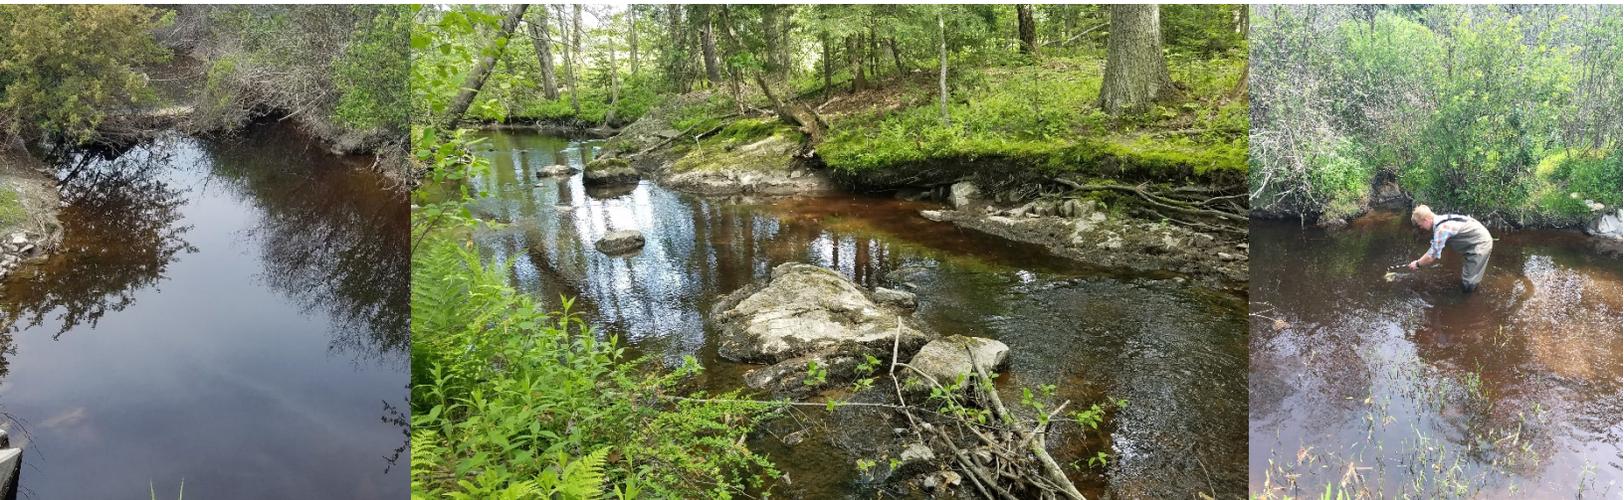
Photos taken in the Goff Mill Brook watershed during water quality sampling. (Left) ponding upstream of Log Cabin Road, (middle) site GOFF-04 near Sinnot Road and (right) Wells National Estuarine Research Reserve WNERR) intern Jacob Watson collecting water at GOFF-003. Photo credit: Jake Aman, WNERR.

Possible sources: Low gradient stream, yard waste in stream, undersized culverts, undercut riparian banks, livestock.

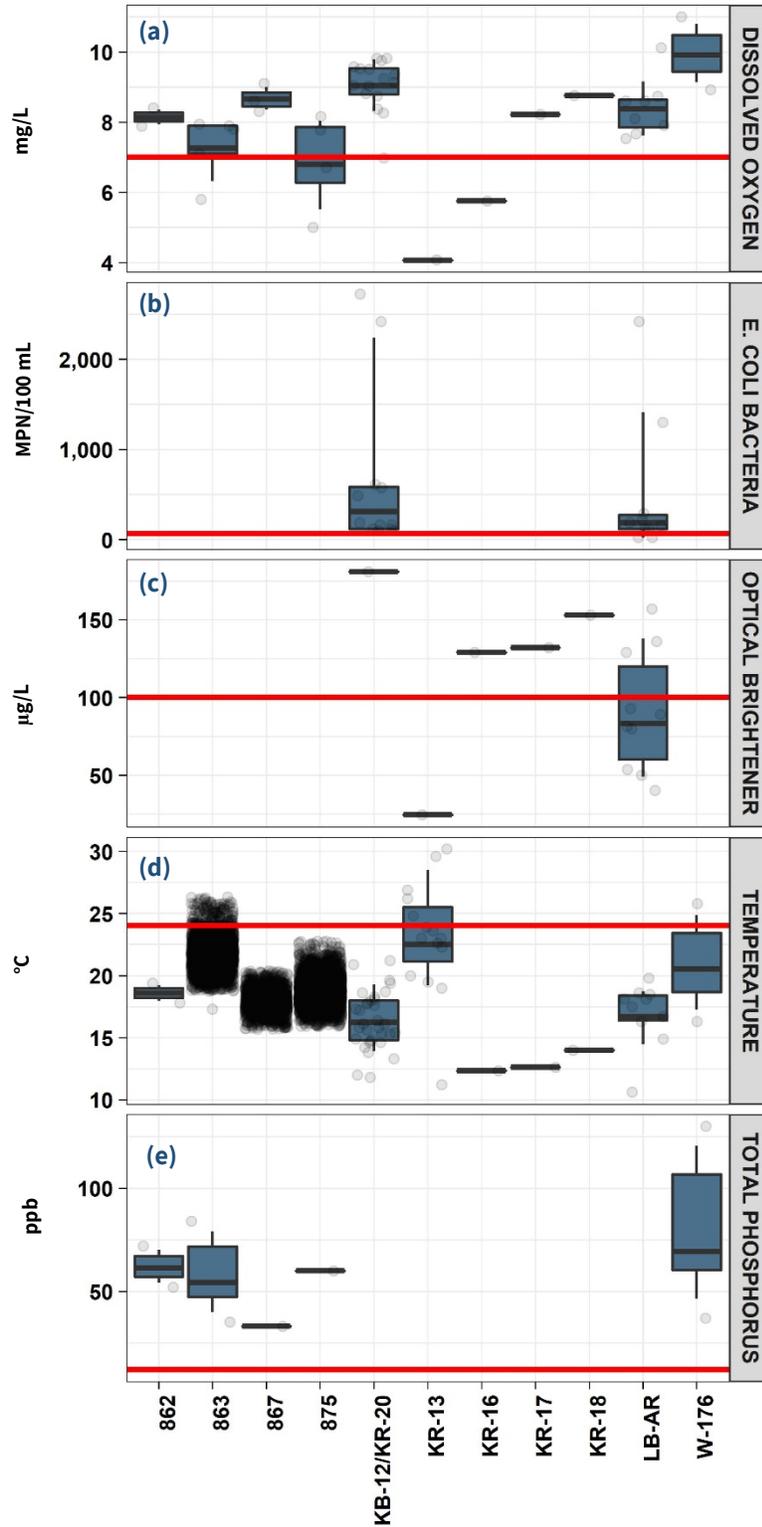
Figure 9. Boxplots showing the geometric mean, 25th, and 75th percentiles for (a) dissolved oxygen, (b) *E. coli*, (c) optical brighteners, and (d) temperature, and (e) total phosphorus in the Lord’s Brook sub-watershed. Temperature at site 863, 867, and 875 reflect a continuous monitoring device. The red line indicates applicable state and federal thresholds for each parameter (refer to Table 1)

Temperature: Temperature data is available for 11 sites and has been collected on a continuous monitoring device for sites 863, 867, and 875. Mean temperature was highest at site KR-13 (mean of 22.5°C, n=15; Figure 9d).

Total phosphorus: Total phosphorus data is available at five site and is elevated significantly at all recorded sites; Figure 9e).

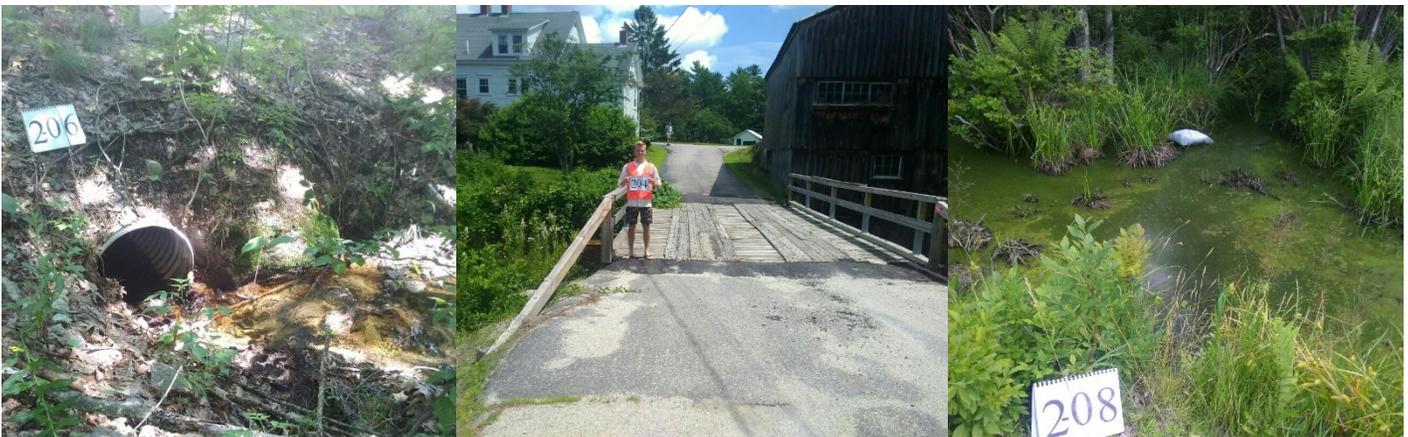
Photos taken in the Lord's Brook sub-watershed. (Left) an unstable culvert bank on Kennebunk Pond Rd, (middle) mobile sediment alongside a bridge crossing Lord's Brook on Lords Road, (right) algae mats in a wetland area alongside the roadway on Waterboro Road near the intersection with Winterwood Rd.

Possible sources: Road erosion, agriculture/manure storage, logging, and impoundments and wildlife/waterfowl gathering.

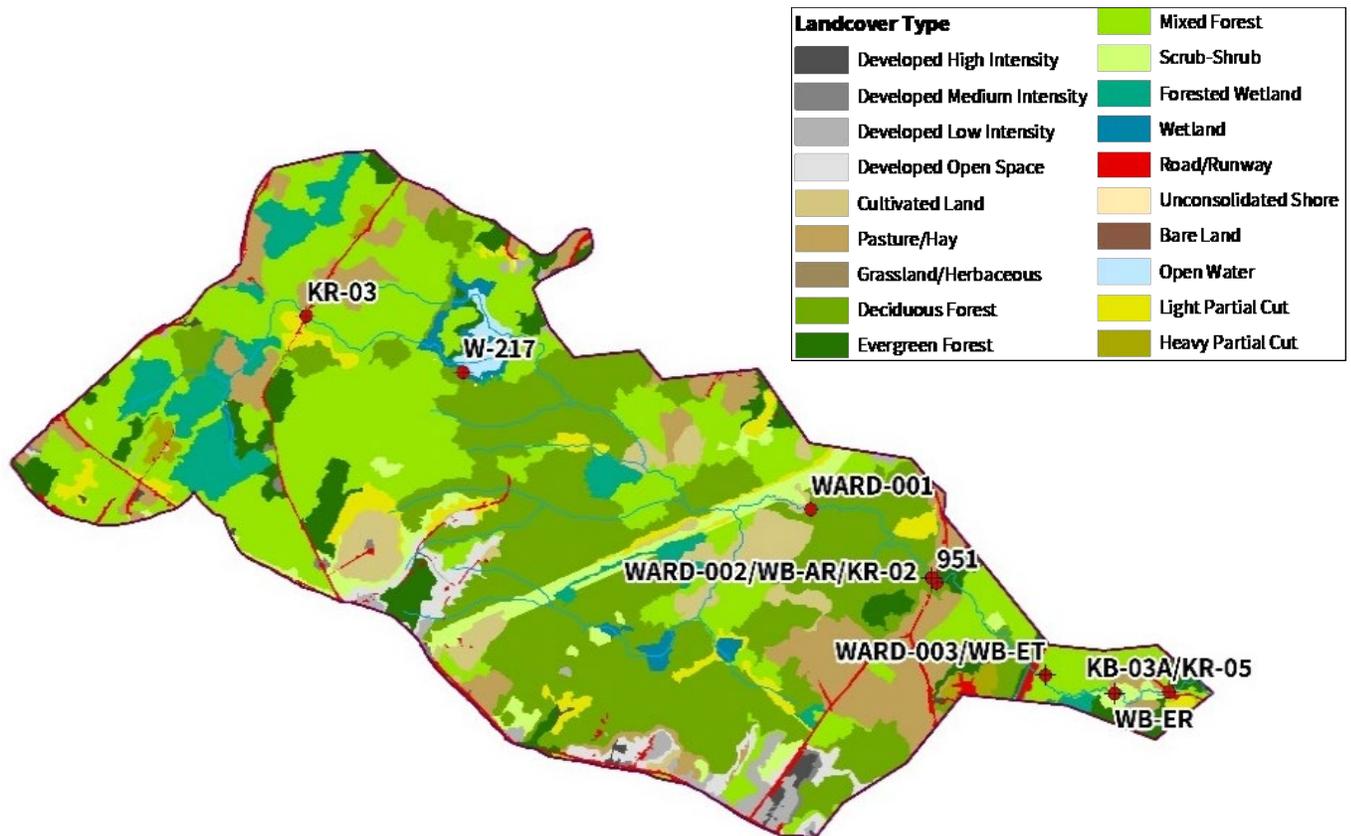
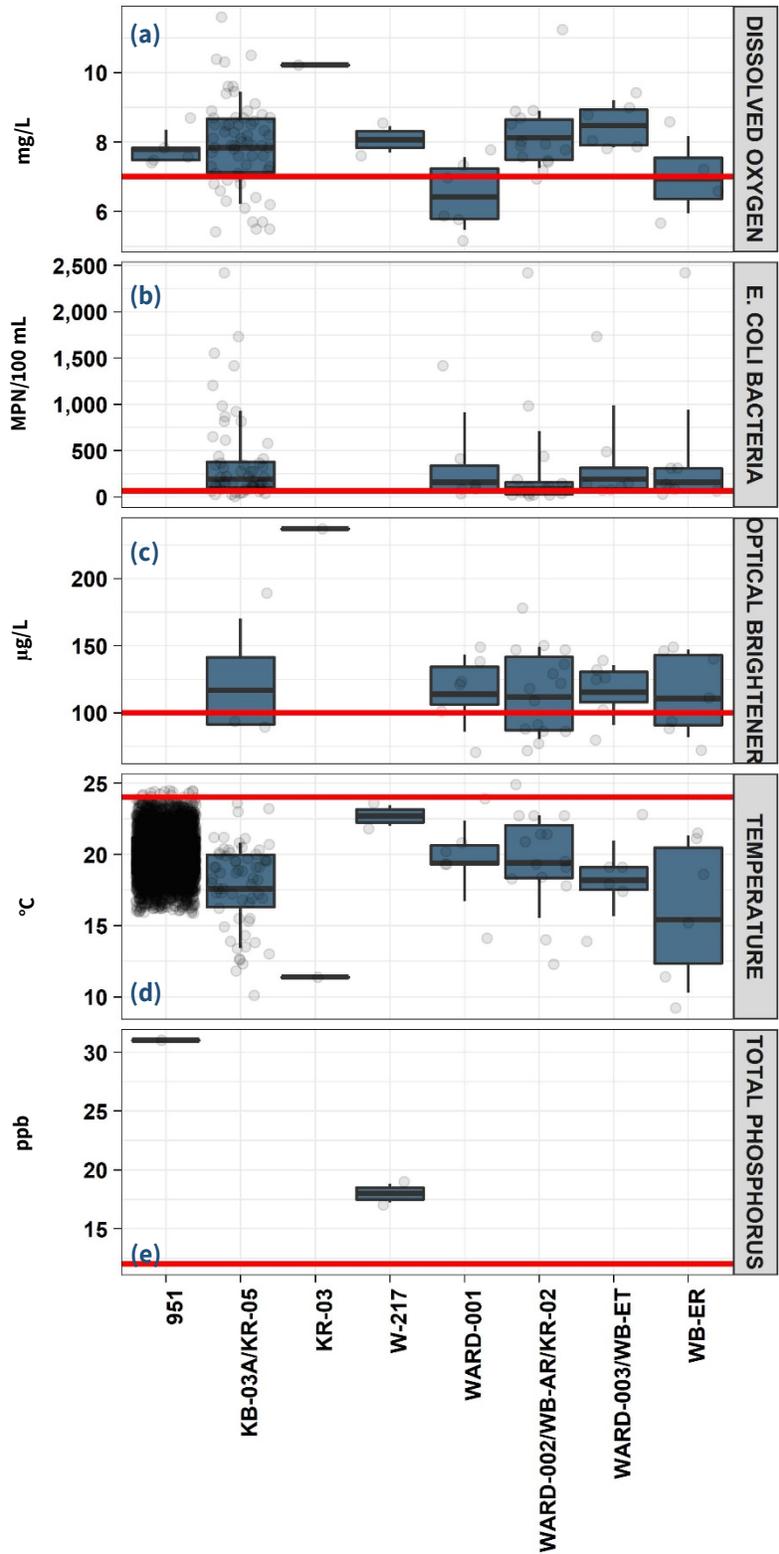
Figure 10. Boxplots showing the geometric mean, 25th, and 75th percentiles for (a) dissolved oxygen, (b) *E. coli*, (c) optical brighteners, and (d) temperature in the Ward Brook sub-watershed. Temperature at site 951 represents a continuous monitoring device. The red line indicates applicable state and federal thresholds for each parameter (refer to Table 1)

Temperature: Temperature data is available for ten sites. Mean (geometric) temperature was below the recommended threshold of 24°C at all sites with the maximum mean temperature at site W-217 (geomean of 22.7°C, n=2; Figure 10d).

Total phosphorus: Total phosphorus data exists at two sites. One sampling point at site 951 at 31 ppb and two at site W-217 with a mean of 18 ppb, both of which are above the threshold of 12 ppb (Figure 10e).

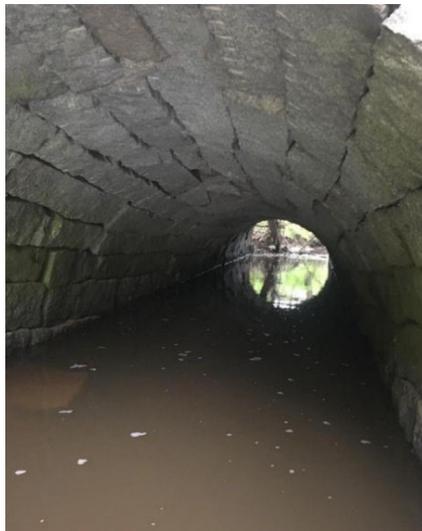
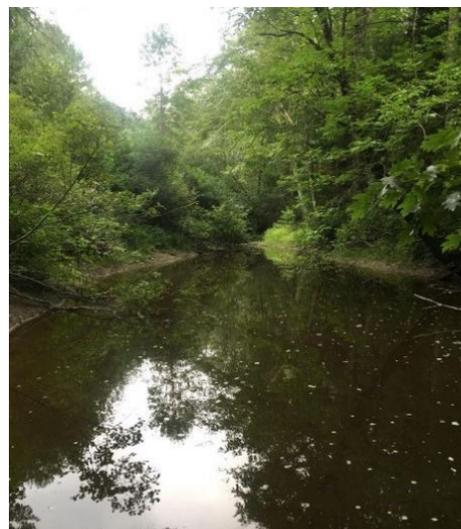
Photos taken in the Ward Brook sub-watershed. (Left and right) Ward Brook crossing at the eastern trail.

Possible sources: Beaver dams, undersized culverts, human and dog waste (from recreational trail users).
