# PROJECTS COMPLETED IN MAINE

## Dead Stream-Bowles Brook

## Stream Crossings

*new designs to restore stream continuity*

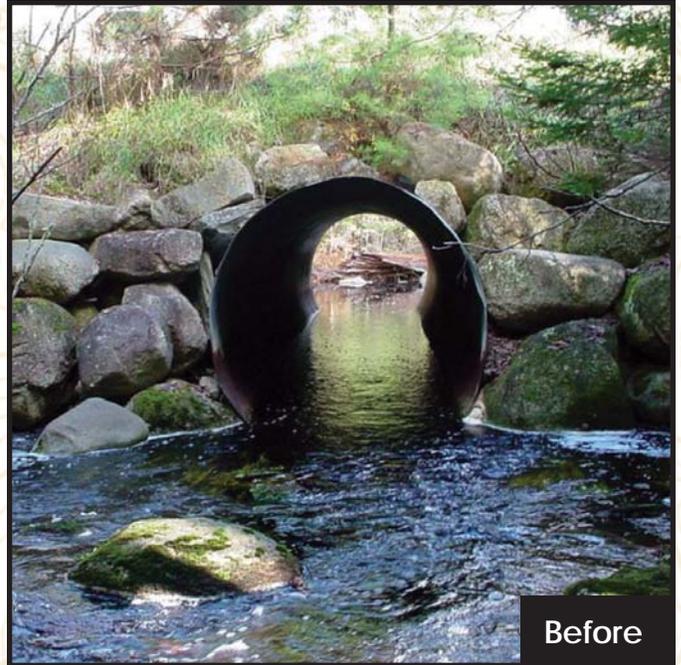
Before

*This undersized round culvert prevented Atlantic salmon and native Eastern brook trout from accessing important habitat.*

An eight-foot round culvert at this site prevented salmon and native Eastern brook trout from accessing over five miles of upstream habitat throughout a large portion of the year. SHARE replaced the existing culvert with a 20-foot open-bottom arch slightly over 1.2 times the bankfull width of the stream. This new crossing passes salmon and brook trout year-round and even provides passage for terrestrial animals. American Forestry Management was the collaborating landowner.

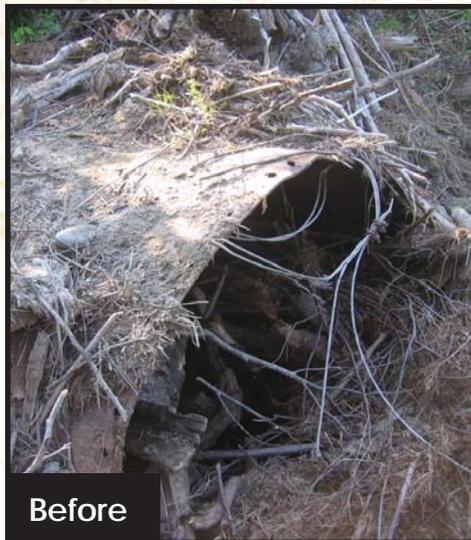
*Before it was replaced, debris would regularly clog this undersized culvert.*

The Maine Forest Service and the U.S. Fish and Wildlife Service Gulf of Maine Coastal Program worked together with the Maine Department of Conservation to replace an undersized and regularly debris-blocked five-foot round culvert with a steel and timber bridge. The new bridge will be able to pass fish at all flows and will allow natural stream processes to convey nutrients, woody debris, and sediment downstream.
